## **Boeing Technical Journal**

# Forty Years of Structural Durability and Damage Tolerance at Boeing Commercial Airplanes

Steven A. Chisholm, Antonio C. Rufin, Brandon D. Chapman and Quentin J. Benson

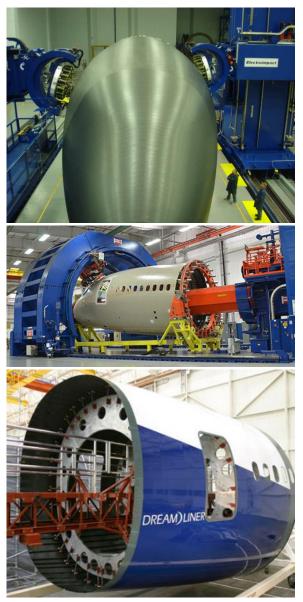
Fig. 22 – Large-scale composite structure manufacturing development for the Boeing 787 program. Numerous fuselage test barrels were constructed at Boeing and at 787 Partner facilities. The first composite fuselage section (bottom) was unveiled in January 2005.

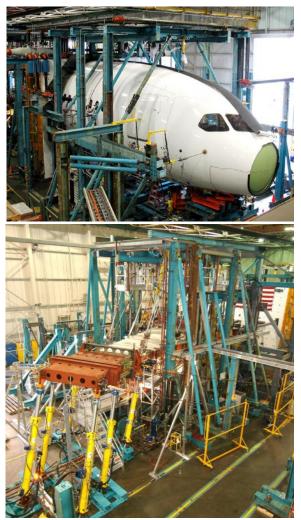
Fig. 32 – Boeing 787 full-scale fatigue test examples: Top: Section 41 (forward fuselage). Bottom: Center wing and outboard wing stub box.

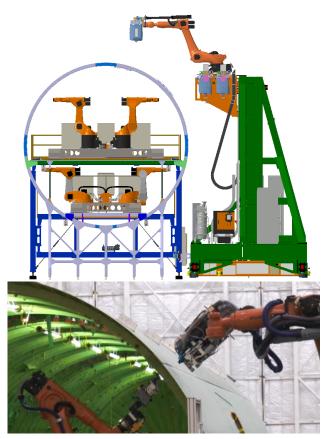
Fig. 39 – The Boeing 777 FAUB fuselage assembly process.

On the Boeing 777 program, the focus is on a radically new fuselage one-up assembly process, FAUB, or Fuselage Automated Upright Build (Fig. 39). With FAUB, aluminum major fuselage sections are now built using pre-programmed, guided robot pairs that fasten the panels of the fuselage together with only minimal fixed tooling. Automated drilling operations will eventually install approximately 60,000 fasteners that are today installed by hand. In addition to benefiting production rates, FAUB will improve workplace safety and increase product quality.

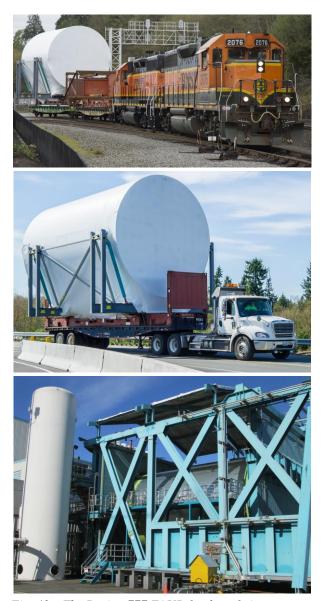
Fig. 40 – The Boeing 777 FAUB fuselage fatigue test article was subjected to pressurization cycles equivalent to three times the design service objective.

Over the course of FAUB machine and process development, hundreds of specimens representative of various joints including riveted and bolted lap and circumferential fuselage splices were tested. Additionally, a 777 Freighter fuselage section featuring both the machine assembly process as well as manually assembled lap splices was built to allow a direct comparison of the current and new assembly methods. The 380-inch (9.65 m) long test article was assembled in Anacortes, WA and was transported by truck, barge and train 53 miles (85 kilometers) to the Everett Boeing facility for fatigue testing (Fig. 40). The test article was subjected to pressurization cycles equivalent to three times the design service objective. Subsequent nondestructive inspections and teardown evaluations demonstrated equivalent or better fatigue performance of the machine assembly process [29].
